**Flood Control Project Maintenance  
Levee Inspections**  
**LMA District Cover Sheet**  
**Spring 2019 Levee Inspection Results**

**Sutter Maintenance Yard Murphy Slough at M&T Ranch**

**Levee Inspection Report By Mile - Spring 2019**

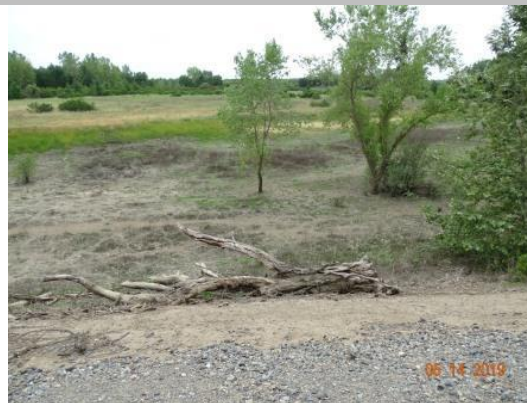
Photo 1 of 1 : SP\_2019\_ST0014\_372\_8\_20190520\_00003.jpg

LM Start	0.31	Rating **	M	Issue No.	8
LM End	0.31	Issue Type +	Ma	Location *	LS
Category	Earthen Levee			GPS Latitude/Longitude	
				Start	End
Item	Encroachments			39.666319 °	39.666319 °
				-121.964544 °	-121.964544 °
DWR ID	DWR_ST0014_01_s_2019_8				
Comment Code					
TR : Tree or limb					
Inspector Comment					
The tree should be removed from the landside toe.

View of the tree at the landside toe. Spring 2019.

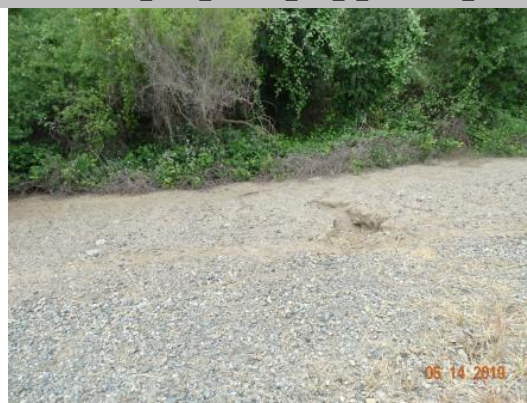
Photo 1 of 1 : SP\_2019\_ST0014\_372\_5\_20190520\_00004.jpg

LM Start	0.56	Rating **	M	Issue No.	5
LM End	0.56	Issue Type +	Ma	Location *	LS
Category	Earthen Levee			GPS Latitude/Longitude	
				Start	End
Item	Erosion / Bank Caving			39.667026 °	39.667026 °
				-121.968890 °	-121.968890 °
DWR ID	DWR_ST0014_01_s_2019_5				
Comment Code					
E2 : Schedule repair of erosion site prior to the next inspection.					
Inspector Comment

View of the erosion on the landside slope. Spring 2019.
